THE POMBORNEIT-WEERITE FIRE

# 8 THE POMBORNEIT–WEERITE FIRE

The Pomborneit–Weerite grass fire was relatively short-lived, being active for about five hours on 7 February 2009 but burning over 1,000 hectares. It started at about 13:15 and quickly burned through grazing land and across a railway line and roads. There was a rapid local response, supported by incident management based in Colac. The fire was contained on 7 February. Damage and losses were limited to stock, crops, hay, fencing and some private infrastructure.<sup>2</sup> Figure 8.1 shows the extent of the fire.

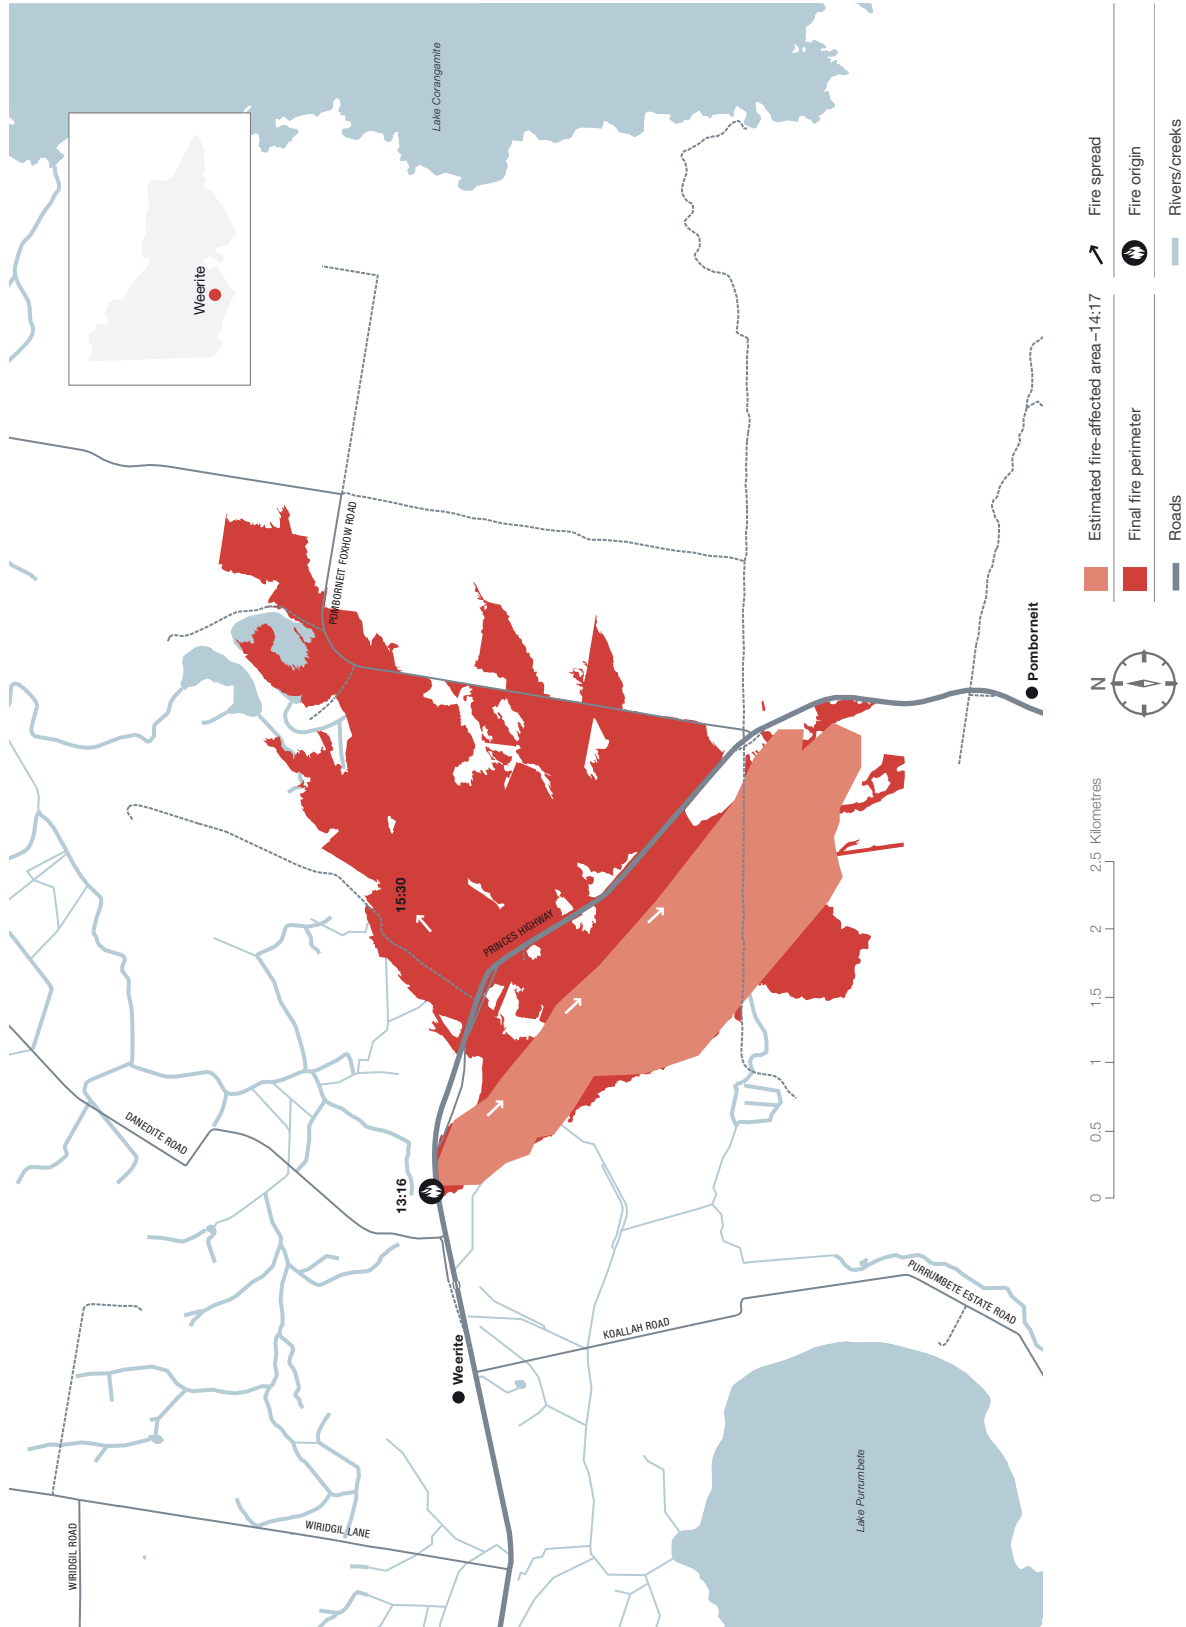
Figure 8.1 The Pomborneit–Weerite fire

Source: Exhibit 994 – Weerite Fire – Fire Spread Map.<sup>16</sup>

The initial run of the fire was south-easterly, crossing and damaging the Geelong–Warrnambool railway line, then running parallel to the line. V/Line was contacted at 13:42, so that it could stop trains using the damaged line.<sup>45</sup>

The expected south-westerly wind change was reported as passing Mt Porndon, about 5 kilometres south of the fire area, at 14:15. The change arrived earlier than expected and pushed the fire north-east, towards Lake Corangamite. The south-westerly wind fanned the fire: flames up to 6 metres high were reported by ground observers.<sup>47</sup>

The fire then crossed the Princes Highway at 14:49 and headed north towards Pomborneit North. During the next one-and-a-half hours it burned unchecked, heading in a north-north-easterly direction towards stony country.<sup>51</sup>

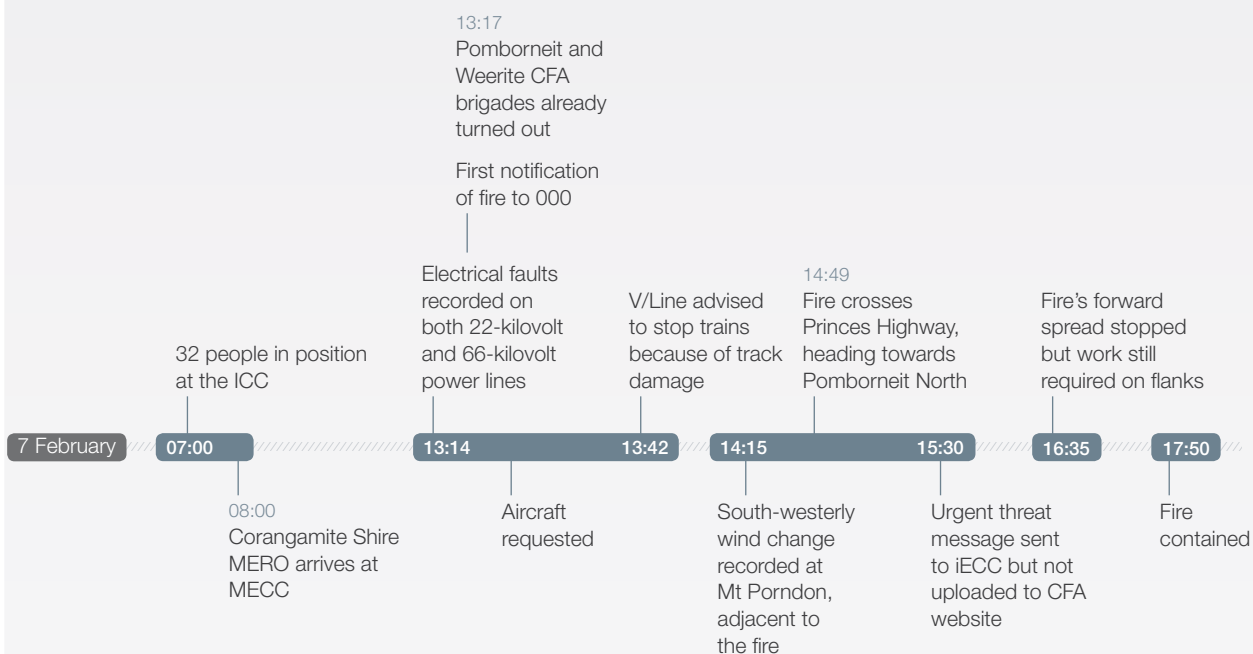
The following time line summarises events associated with the Pomorneit–Weerite fire. For the most part, the times given are approximate. Further details about the events are provided in the accompanying narrative.
